Determination of impact of VDSL interference on the Amateur Radio Service.

Final Report v2.0

This report shows the results of testing the impact of VDSL2 RFI on Amateur Radio at six sites selected as representative from those reported in the members survey aimed at determining the extent of the RFI. The sites chosen were close to Baldock to allow Ofcom to conduct their own measurements at these sites.

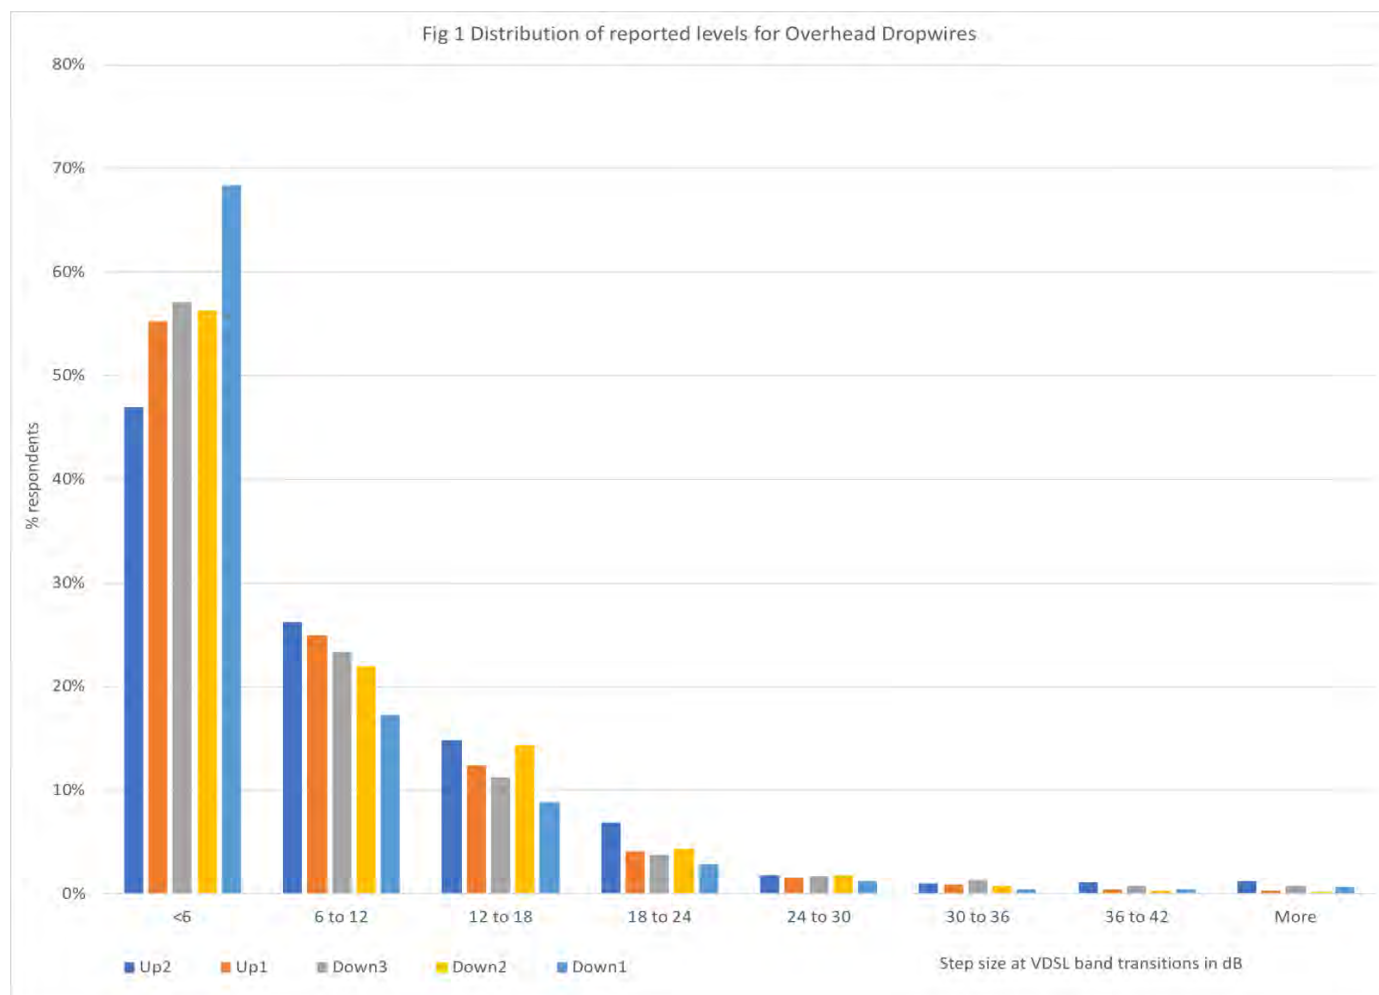
More than 50% of our survey respondents found steps of more than 6dB at one or more VDSL band transitions, half of these or more than 25% found steps of more than 12dB. Histograms for each of the VDSL bands are shown in Figure 1.

This shows more problems with RFI from upstream than downstream. Actual RFI Levels found for underground feeds were higher than expected at only 5 to 10dB below overhead drop-wires. We believe in house extensions act as the antenna in these cases. Detailed comparison for different bands is plotted in Fig 1 below.

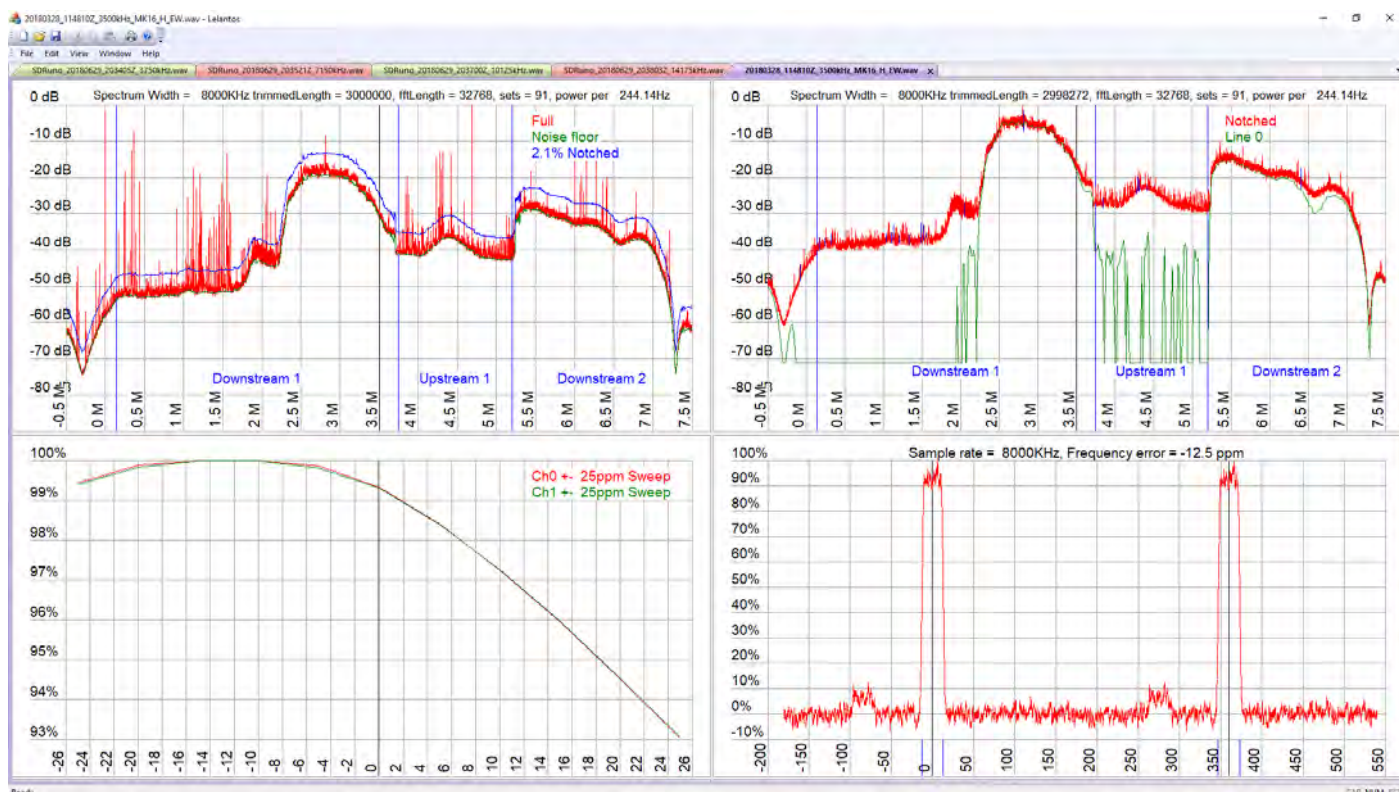
Figure 2 output from Lelantos VDSL measurement package

Due to small calibration errors in the frequency of the SDR sampling the exact sample rate can be slightly off. The bottom left graph shows that Lelantos did a sweep to find the peak and concluded that the sampling rate was off by -12.5 parts per million. The very close accuracy is extra confirmation that we are seeing VDSL2.

The top left graph in the screen shot shows the full spectrum of the SDR wave file. This spectrum is shown as power per 244.14 Hz (8MHz / FFT length 32768). It is accumulated over the 3 Million waveform samples as the graph heading says. The gain of the SDR and loop is unknown so 0dB is shown as the strongest peak.

Strong peaks due to narrow band signals can cause beat effects during the correlation that is done to detect the VDSL2 CE. To avoid this problem Lelantos identifies all peaks that are more than 6dB above the local noise floor and notches them out. The top left graph shows the noise floor (green) and the 6dB threshold (blue). In this case a total of 2.1% of the bandwidth is notched out in removing these multiple peaks.

During the first stage of processing these notches are applied and the new samples generated. The top right graph shows the result when these processed wave samples are then spectrum analysed. These wave samples are the ones that are in fact used to produce the correlation shown in the bottom right graph. Since the VDSL2 signal is broad band the notching out of 2.1% of its channels does not otherwise affect the correlation.

The strength of the VDSL2 interference reported in the bottom right graph is +7.5dB when compared with the total power of all other signals in the 8MHz bandwidth excluding the 2.1% notched. The 2.1% can be thought of as the signals that would be received in the presence of the VDSL RFI.

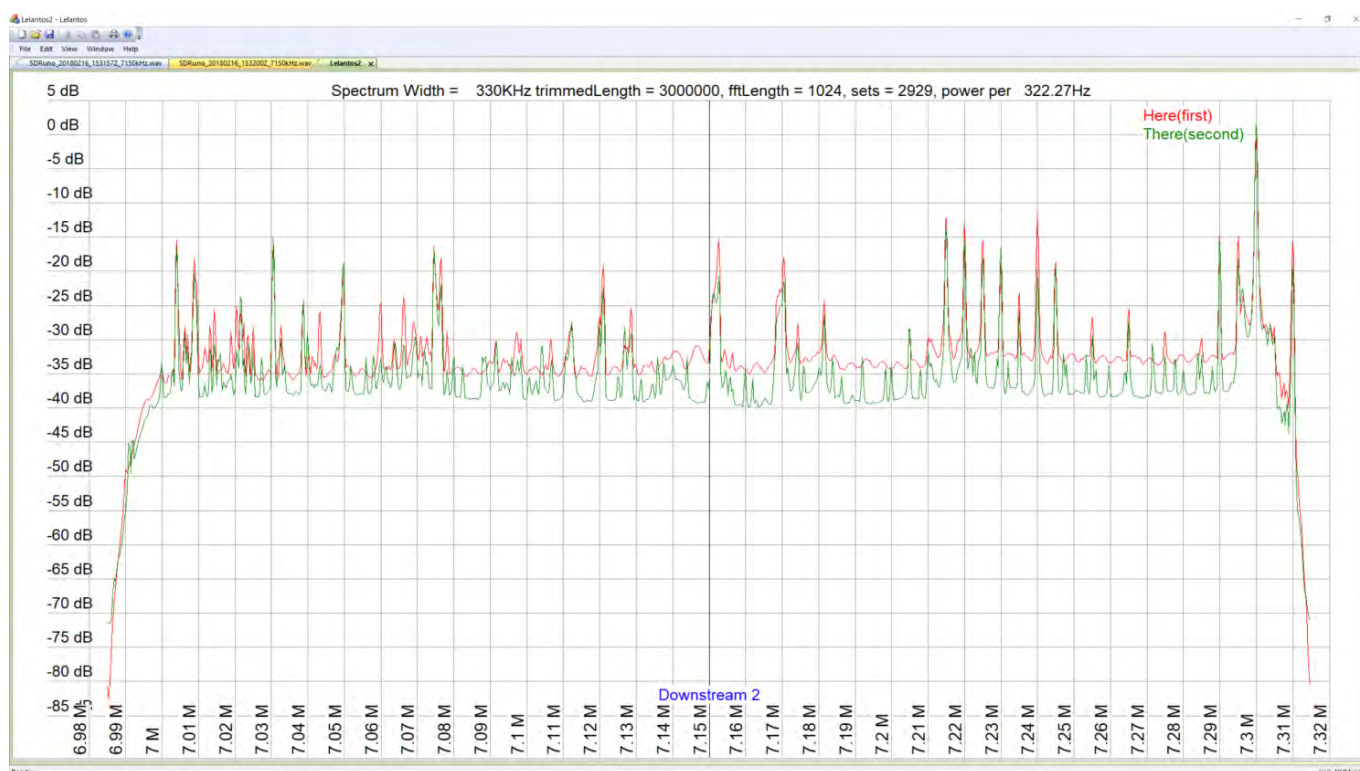
Comparison of spectra at the two locations from simultaneous recordings using equipment of the same type at nearby locations clearly shows the obscuration of many signals by the VDSL RFI noise level. In this example in this timeslot about 90 signals can be seen at the “There” location (green line) and under half of those can be seen at the “Here” location (red line). The red line also clearly shows the 4.3125kHz ripple characteristic of VDSL signals.

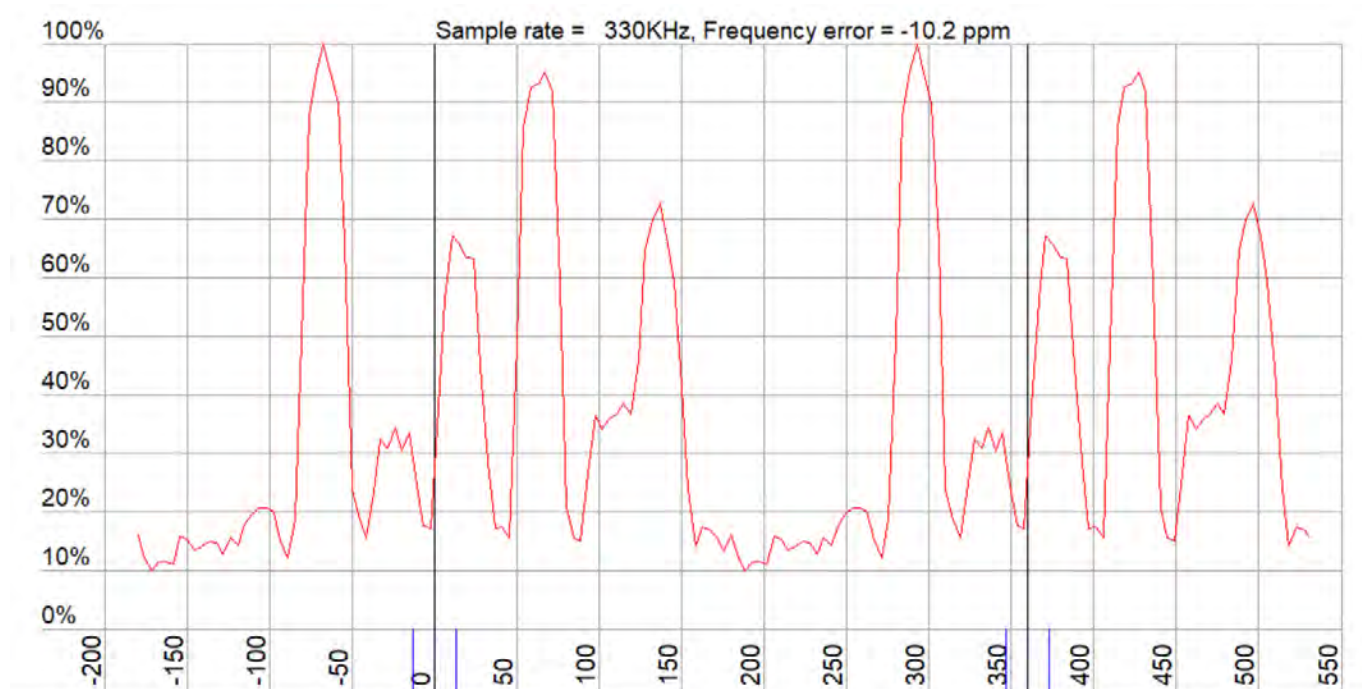
Secondly using the correlation analysis it is possible to determine how many VDSL RFI sources are being detected. In this case Lelantos shows two strong and four weaker correlated VDSL sources

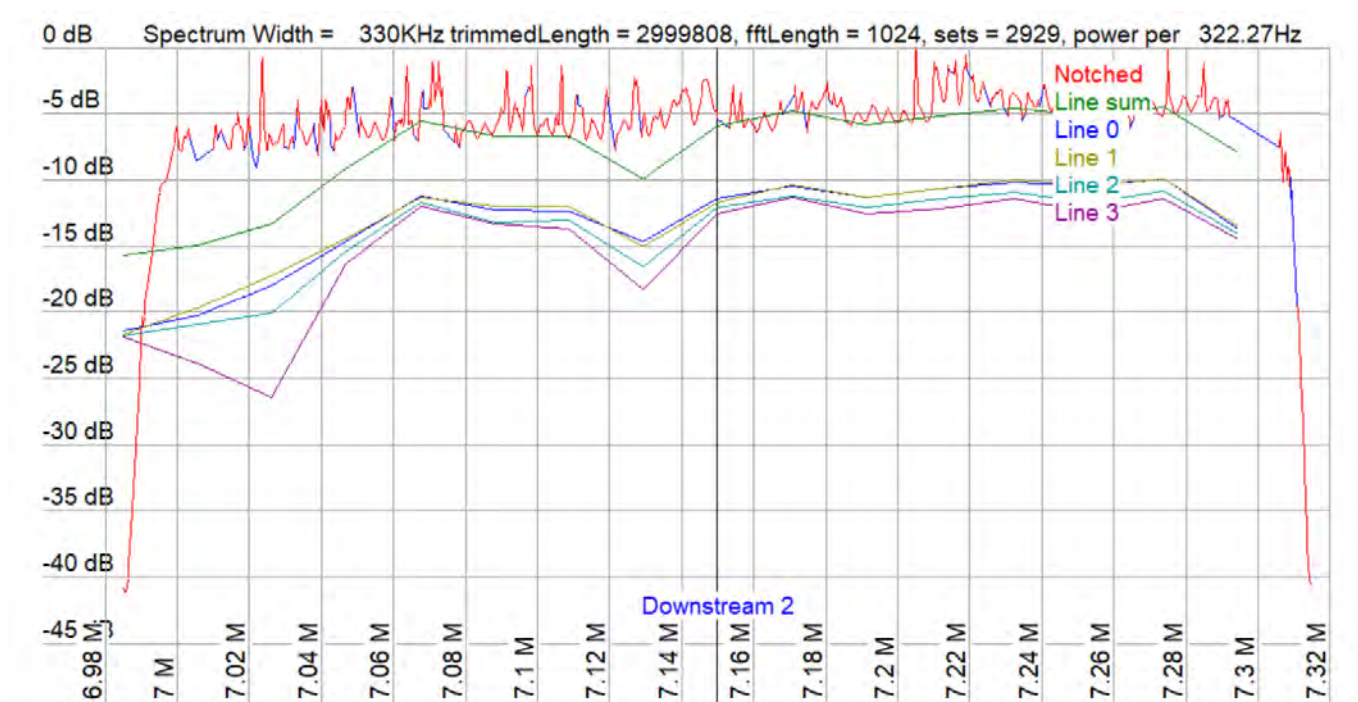
Next the power in the spectrum can be measured for each of the individual VDSL lines and summed to give the total power from the VDSL lines, in this case the power level of VDSL RFI being only 6 dB lower than the peak level of real signals at the here location.

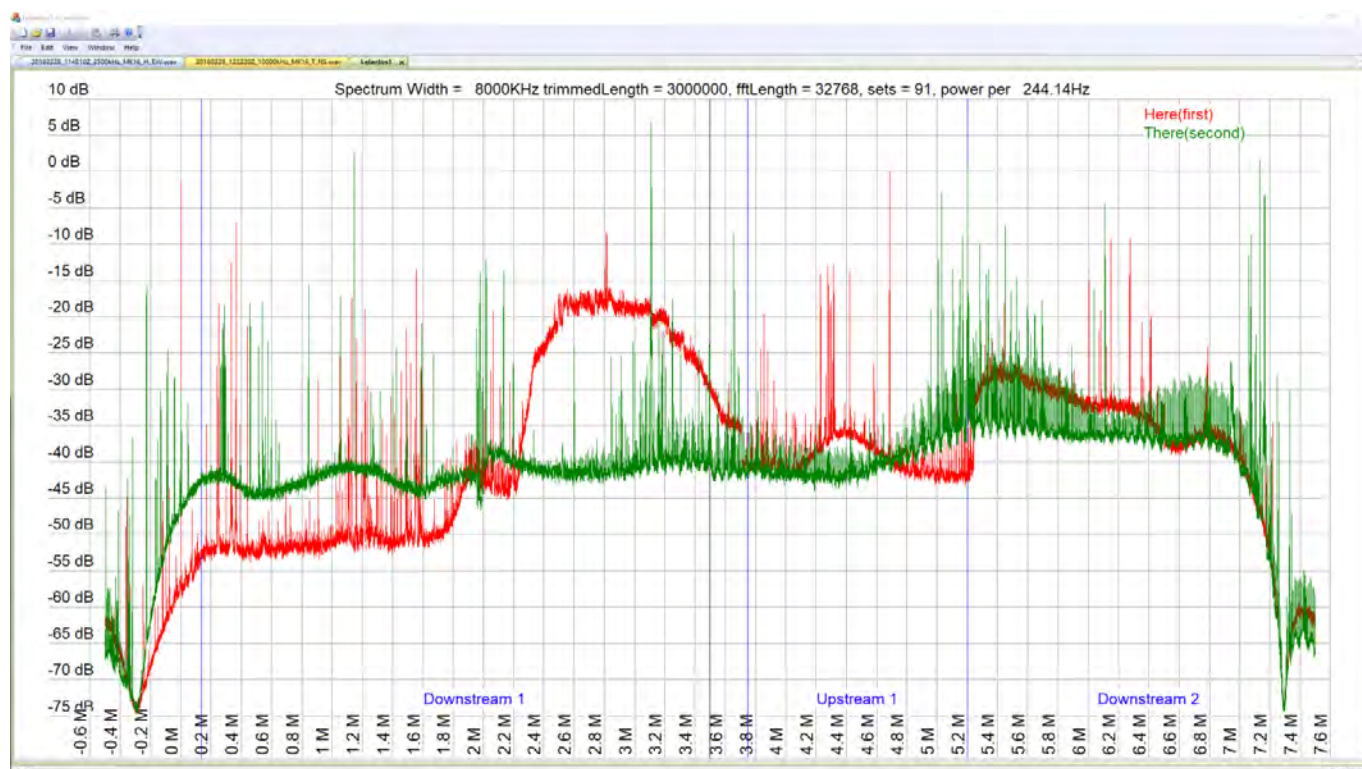
At Location 1, an East-West orientation of the antenna was used as this gave a higher signal level than North-South. At Location 2, a North-South orientation of the antenna was used as this gave a higher signal level than East-West.

Lelantos 1.8 - 7 MHz. Location 1 (here), East-West showing very significant VDSL noise, Location 2 (There), North-South showing moderate VDSL noise. Note in DS1 band, noise at Location 1 is 23dB above location 2.

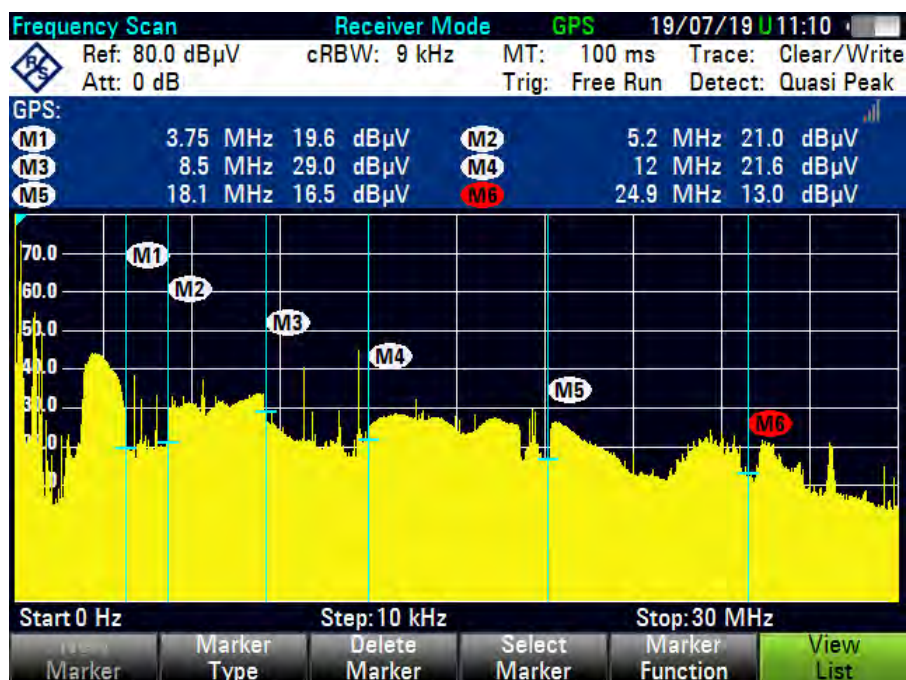
Trace0843, 0 - 30 MHz, 10 kHz step, 9 kHz RBW, QP Detector

The following measurements are with Rohde & Schwarz FSH8 spectrum analyser in Receiver mode with Quasi-Peak (QP) detection and 9 kHz bandwidth. The frequency range was 0 - 30 MHz with 10 kHz receiver step size, giving a total of 3000 measurements. The measuring antenna was a Wellbrook ALA1530 loop antenna S/N 7474 and a separate 1.8 MHz High Pass Filter (HPF) was used.

The measuring antenna was mounted on a non-conductive tripod with the lowest part of the antenna 1 m above ground. The measuring location was outdoors near the front door of the house, 3 m horizontally from the telecommunications network (overhead dropwire) but the location had not been selected as having the maximum disturbance field strength. The measuring antenna was rotated and tilted to give the maximum disturbance signal from the telecommunications network.

The amplitude units are dB(uV), the antenna factor has not been included. The purpose of the test is to evaluate the measurement procedures and limits defined in CEPT ECC Recommendation (09)02 [2].

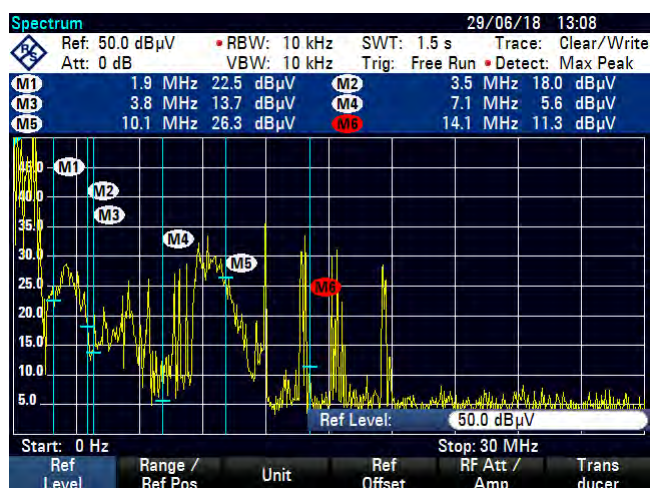
Overhead dropwires "A" and "B" go from DP 78 outside the front of the radio amateur's premises to another DP just outside the rear boundary of the radio amateur's premises. From there, dropwire "C" feeds the next door neighbour's house. Another dropwire (not accessible) feeds another house to the rear of the radio amateur's premises.

Screen2225, 0 - 30 MHz, current on dropwire 'A'

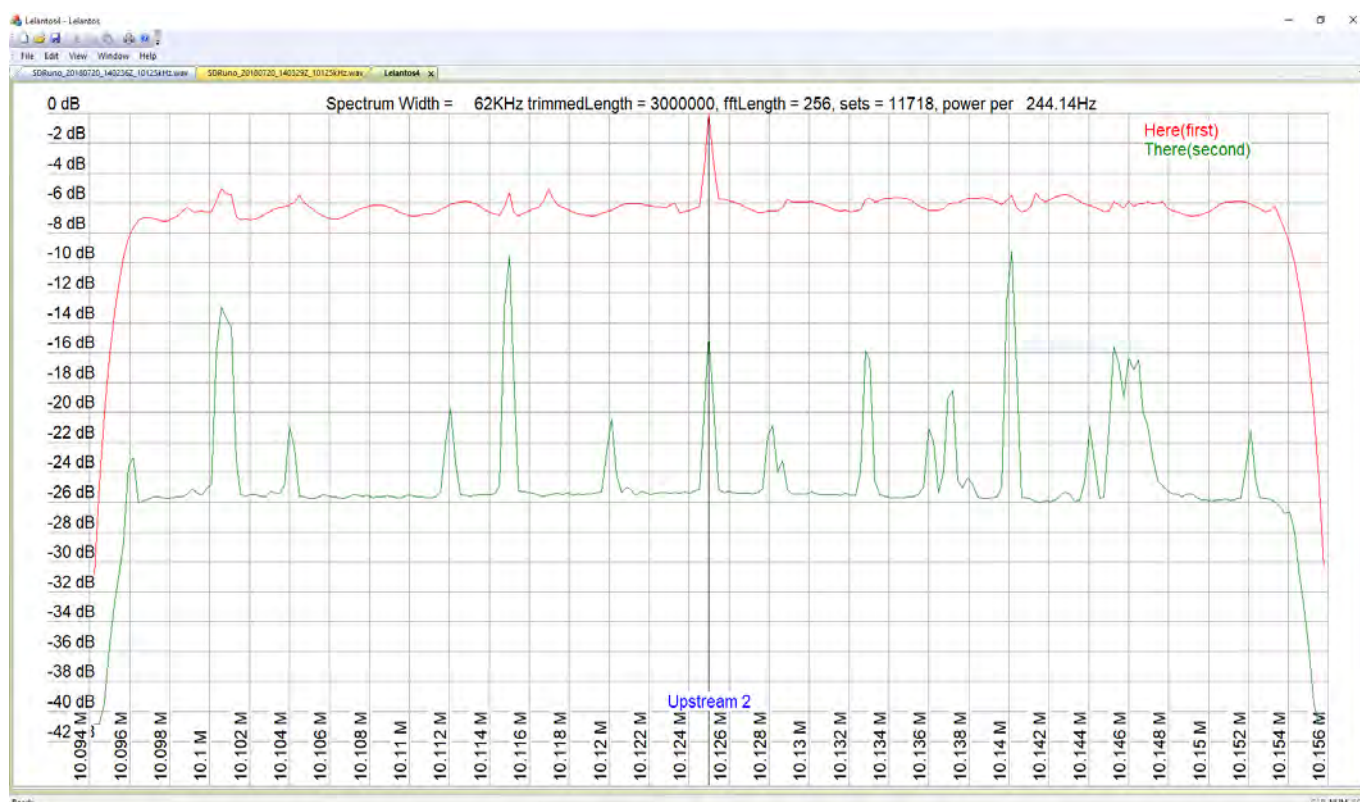
Lelantos 10.098 - 10.152 MHz.

Location 1 (here) showing very significant VDSL noise. Location 2 (There) showing no evidence of VDSL noise.

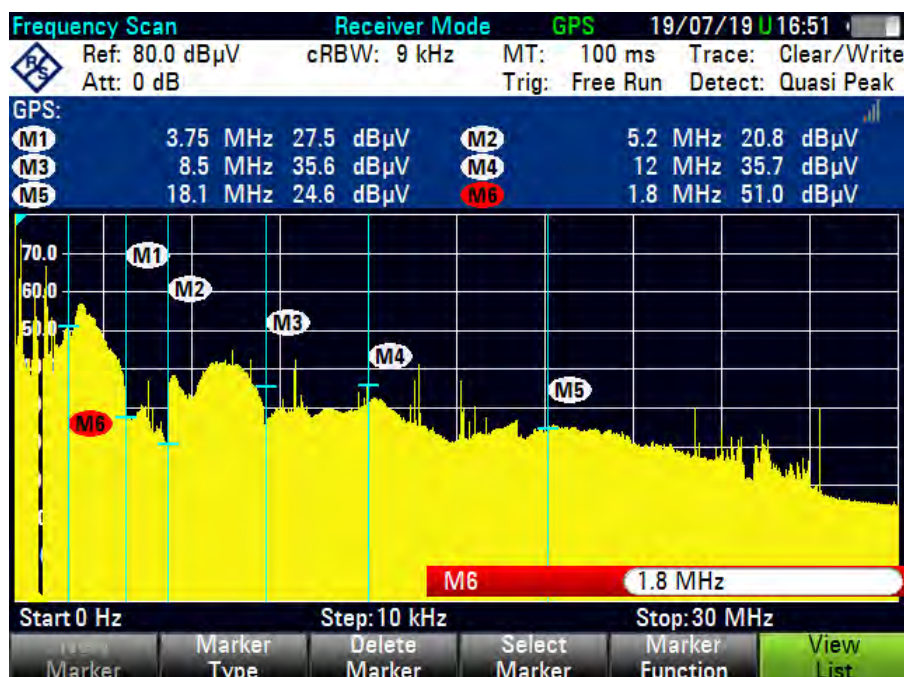
Trace0850, 0 - 30 MHz, 10 kHz step, 9 kHz RBW, QP Detector

The amplitude units are dB(μ V), the antenna factor has not been included. The purpose of the test is to evaluate the measurement procedures and limits defined in CEPT ECC Recommendation (09)02 [2].
